NASA CR-159798
IITRI-M6003-53

THERMAL FATIGUE AND OXIDATION DATA
FOR DIRECTIONALLY SOLIDIFIED
MAR-M 246 TURBINE BLADES

V. L. Hill and V. E. Humphreys
Materials Technology Division

IIT RESEARCH INSTITUTE
10 West 35 Street
Chicago, Illinois 60616

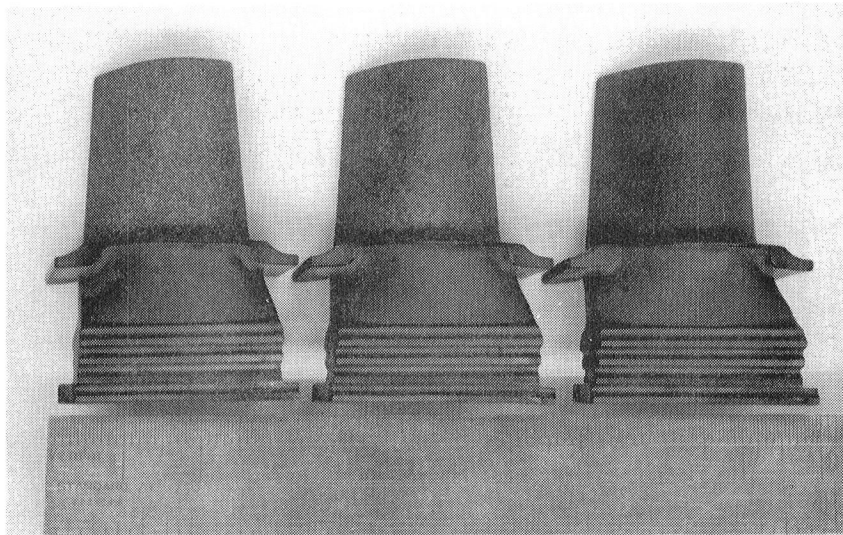
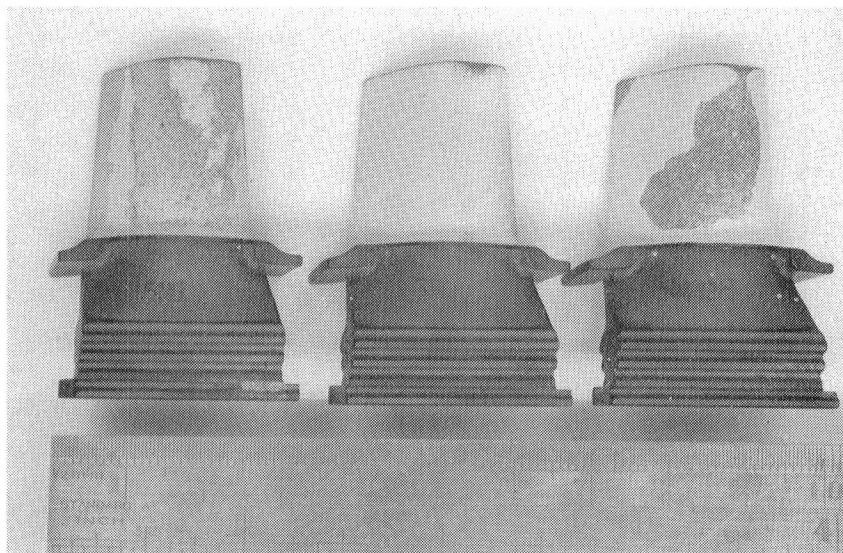
Figure 11

Figures 7 to 10 show the surface appearance of the test blades as received. The appearance of the blades after 3000 cycles are shown in Figs. 11 to 14. Spalling of the coatings on the airfoils of blades 4 and 6 is readily apparent in Fig. 11. Localized spalling at the tip of the trailing edge on blade 7 can be seen in Fig. 12. For the remaining coated blades, localized spalling at the trailing edge radius was observed under the 30X microscope, although this effect is not evident in Figs. 11 and 12.

Weight loss of plasma-sprayed thermal barrier coated blades was due to spalling of the coatings. General spalling was apparent for blades 4 (multilayer Ni-20Cr + ZrO₂-5CaO) and 6 (multilayer Ni-20Cr + 30(Ni-20Cr)-70(ZrO₂-5CaO) + ZrO₂-5CaO) after 3000 cycles. All of the remaining blades indicated microscopically visible spalling, particularly at the radius of the trailing edge.

Appearance of Turbine Blades 1-6 after 3000 Thermal Cycles at $950^{\circ}/25^{\circ}\text{C}$ ($1742^{\circ}/77^{\circ}\text{F}$). Note spalling of thermal barrier coating on specimens 4 and 6.

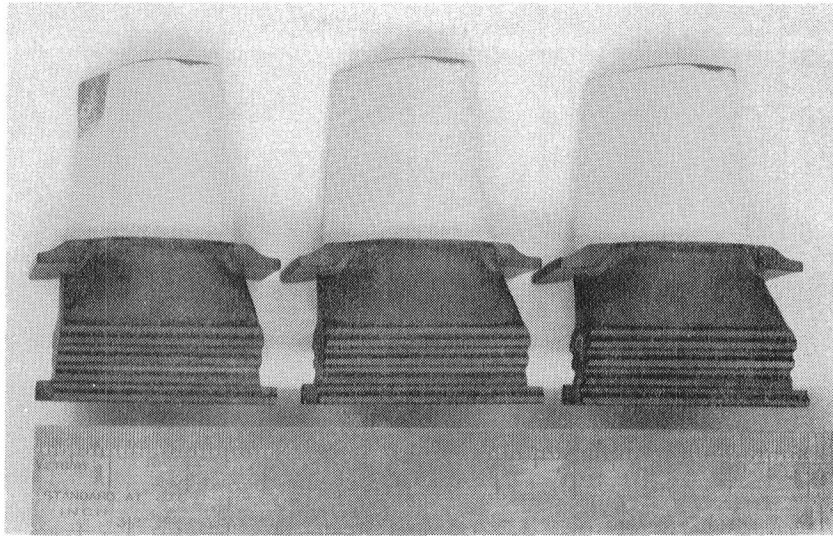
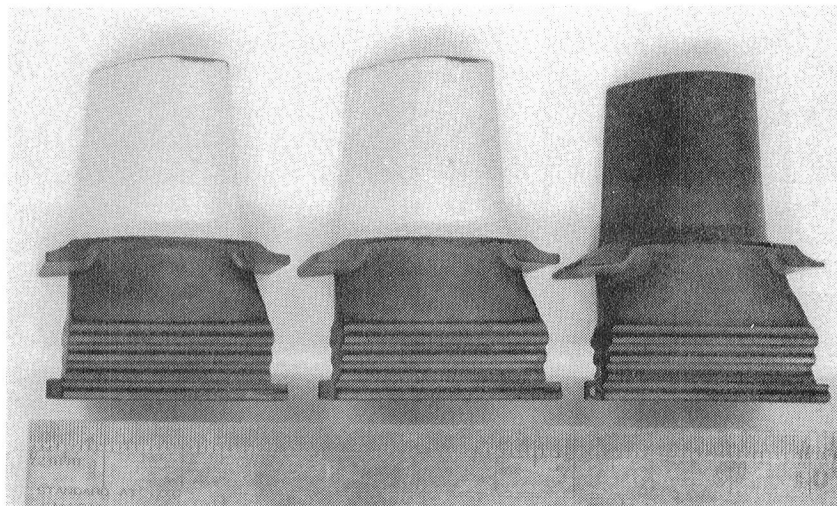
Figure 12

Appearance of Turbine Blades 7-11 after 3000
Thermal Cycles at 950°/25°C (1742°/77°F)

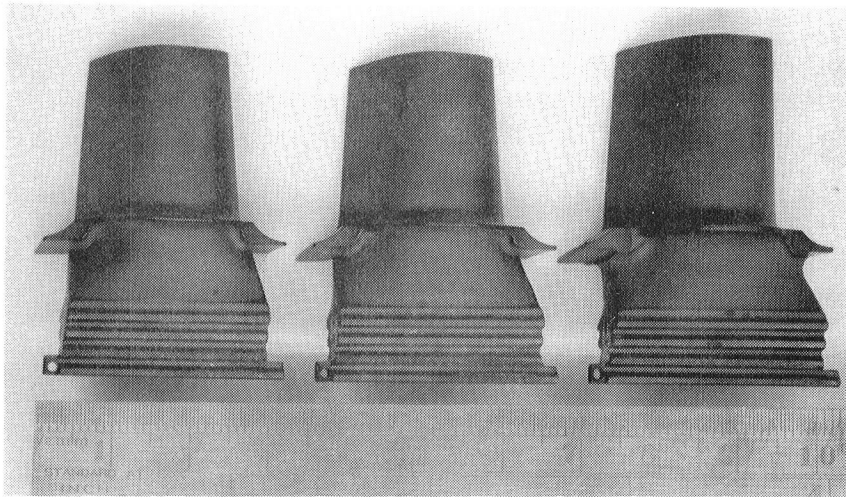
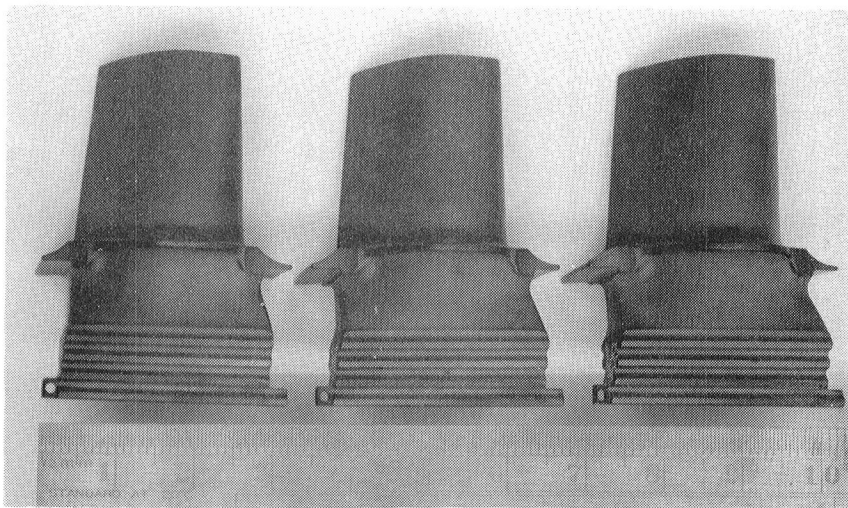
Figure 13

Appearance of Turbine Blades 13-18 after 3000
Thermal Cycles at 950°/25°C (1742°/77°F)

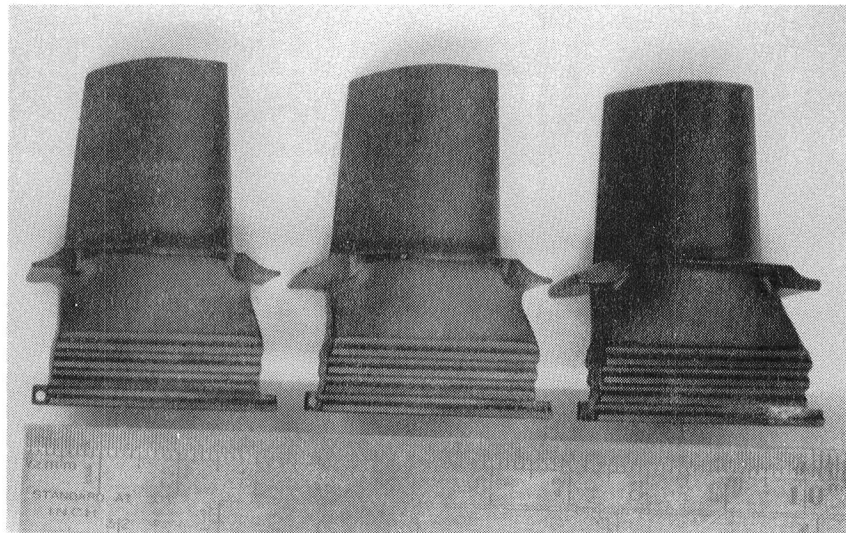
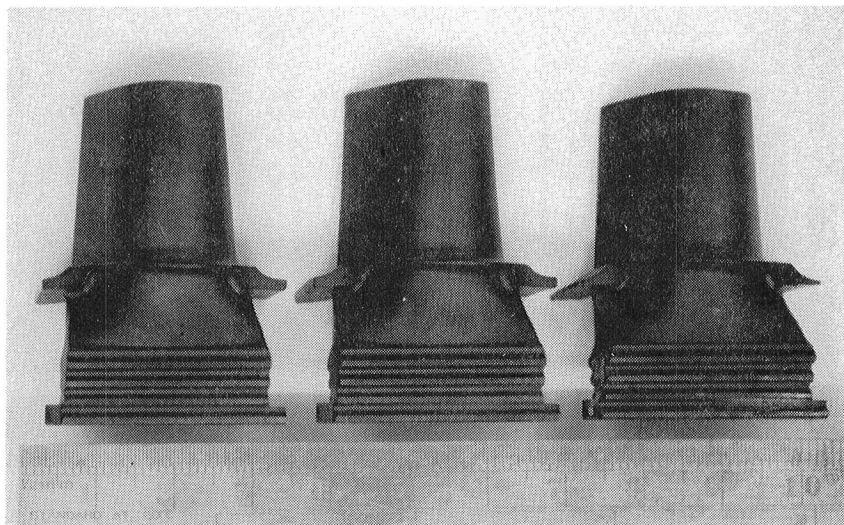
Figure 14

Appearance of Turbine Blades 19-24 after 3000
Thermal Cycles at 950°/25°C (1742°/77°F)

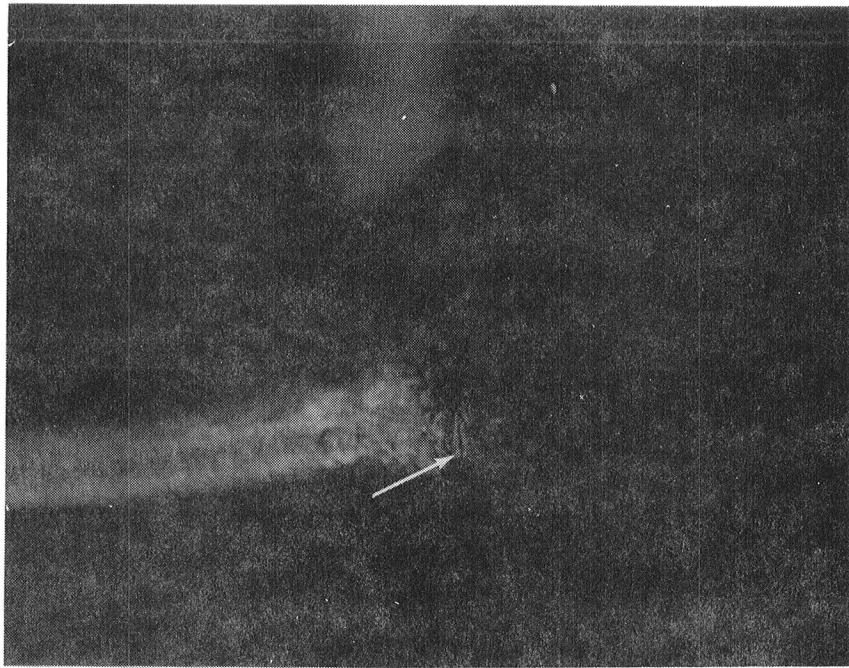
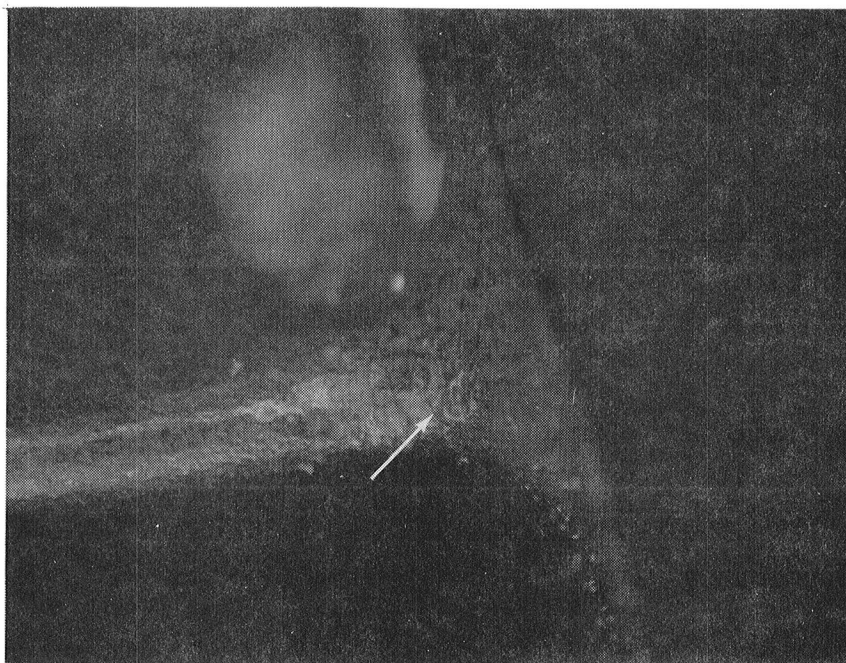
Figure 15

Data in Table 10 indicate that in most cases the blade cracks occurred on the trailing edge at, or near, the root of the airfoil at the platform. An exception was one of the two

cracks observed on blade 12 at 3000 cycles. The remaining blade cracks were observed at a distance of 17 to 24 mm from the blade tip; the blade length was approximately 25 mm at the trailing edge. Crack lengths were relatively short, less than 1.0 mm, and often cracks did not propagate significantly with accumulated thermal cycles. The estimated visible detection limit for cracks was 0.25 mm. Uncoated blades 14 (DS, unetched) and 21 and 22, both etched DS blades, did not crack in 3000 cycles at 950°/25°C.

Figures 15 and 16 show typical thermal fatigue cracks at the trailing edge (blades 15 and 17) and on the platform (blades 12 and 21), respectively. Cracks in Fig. 15 were located on the radius of the trailing edge at the platform.

Typical Thermal Fatigue Cracks on Trailing Edge
Radius at Platform of Turbine Blades 15 and 17

Although thermal fatigue cracks did not propagate rapidly during thermal cycling in this program, axial loading due to turbine operation would likely modify crack propagation behavior. Imposition of more severe thermal transients than could be obtained in the fluidized bed would also probably reduce thermal fatigue life. Redesign of the blade to provide a more generous radius at the trailing edge may improve thermal fatigue life of the DS blades.

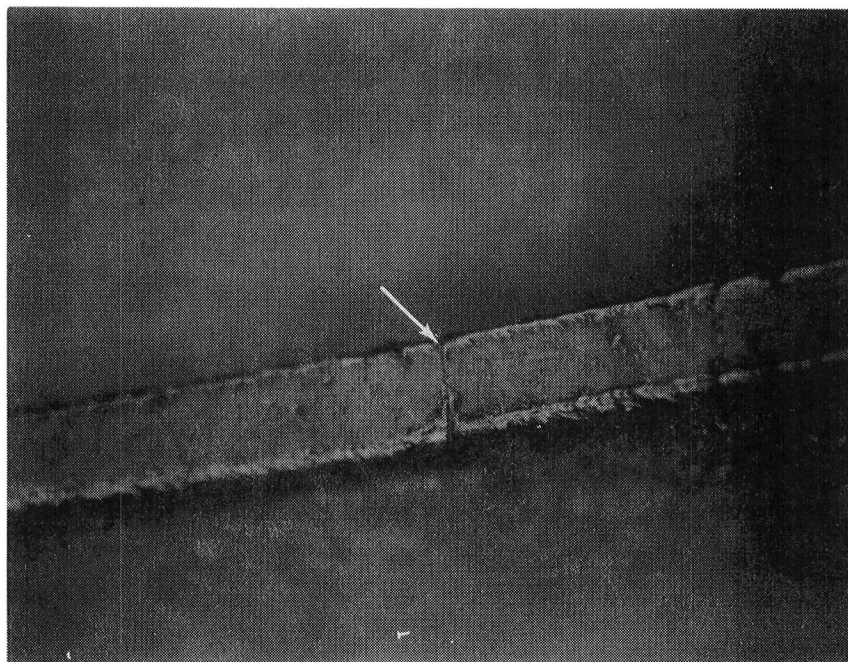
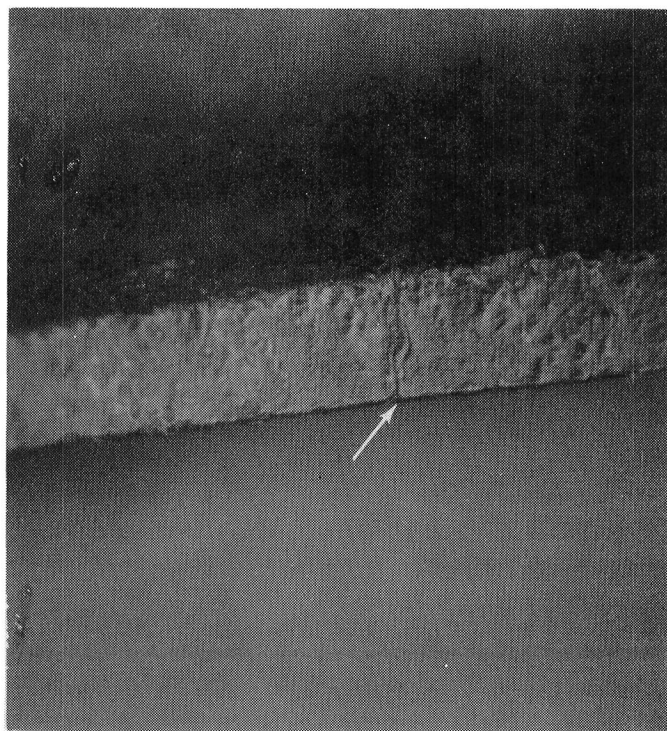
In addition to blade cracks, 10 of the 24 blades exhibited cracks in the platform on the concave side of the blade at 3000 cycles, as shown in Table 10. The platforms were not coated, since thermal barrier coatings were limited to the airfoil. Of the 10 blades that exhibited platform cracks, 7 were coated blades; only coated blades 8, 9, 10, and 11 did not exhibit platform cracks at 3000 cycles. Uncoated blades that exhibited platform cracks were specimens 12, 19, and 21.

All platform cracks, which were previously noted to be located on the concave side of the blade, were generally located between the blade centerline and the leading edge. These cracks had generally propagated through the platform cross section to the blade surface. In some cases (blades 3, 12, 19, and 21) two cracks were observed in the platform.

Platform cracking observed in this program is probably less significant than blade cracks observed. These cracks are not likely to be propagated by turbine operation; axial loading should not be significant. Since platform cracks were located near the leading edge, interaction with trailing edge cracks is not likely.

Typical Thermal Fatigue Cracks on Blade
Platform Concave Side of Blades 12 and 21
